# San Francisco Water System Impact of Lead Components on Household Lead Levels at the Tap

MARCH 2022

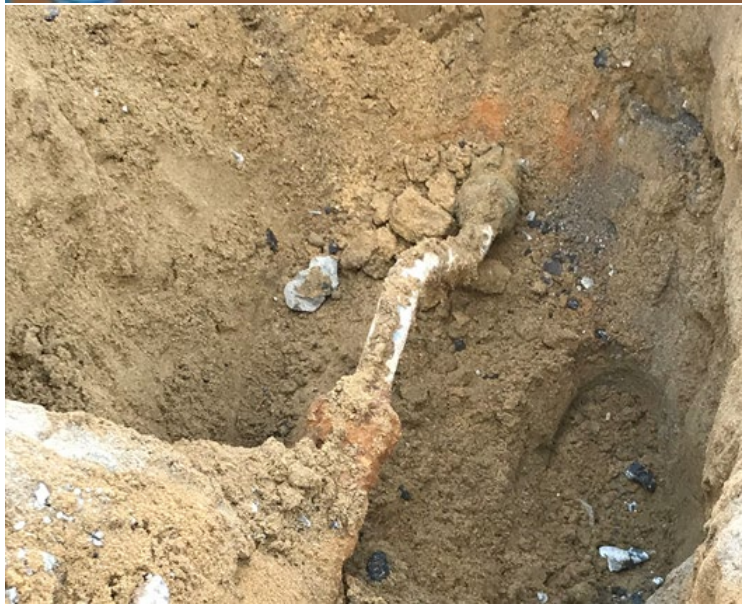
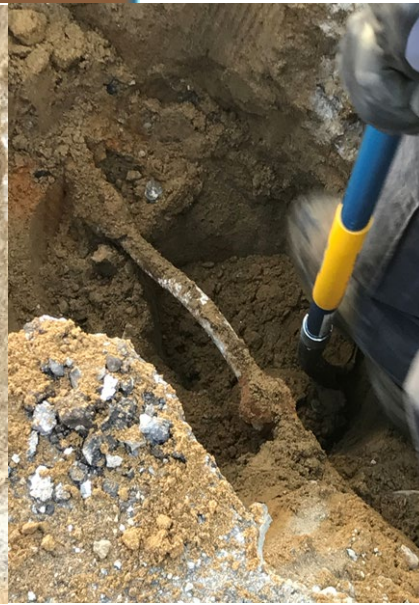
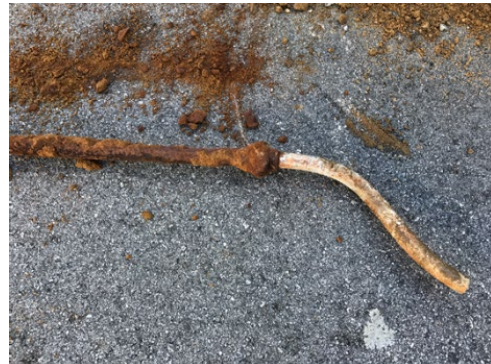
Figure 3. Service Line Plumbing Components and Whip/Pigtail Pictures (top to bottom): a- plumbing schematic, b- flexible lead whip connecting water main to service line, c- lead whip being removed, d- removed lead whip)

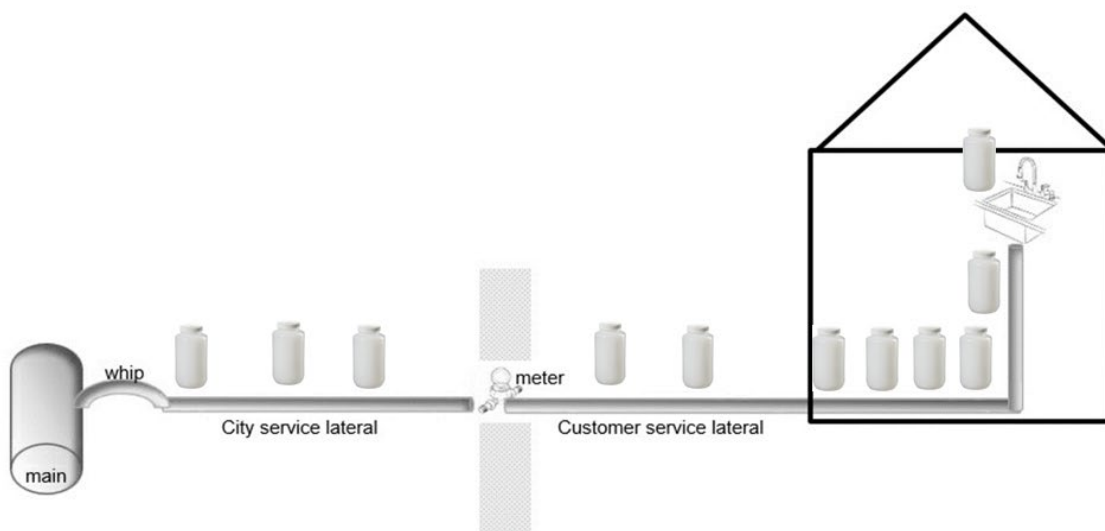
Figure 6. Schematic Representation of Profile Sampling  
(number of sample vessels varies based on plumbing lengths)

- Sequential Sampling – Several 1L bottles are filled one after another to capture the entire volume of water in a plumbing system from tap to main.
- Survey – customers completed a certification statement indicating that they followed the sampling protocol or provided notes if procedures could not be followed (See Appendix I for sampling instructions and forms completed by participant).
- Sample Transport – Samples were immediately packed in cooler with ice for pickup by SFPUC the day of sampling. SFPUC field technicians checked the Chain of Custody forms for completeness. Samples were transported to the SFPUC’s certified Southeast drinking water laboratory for analysis.

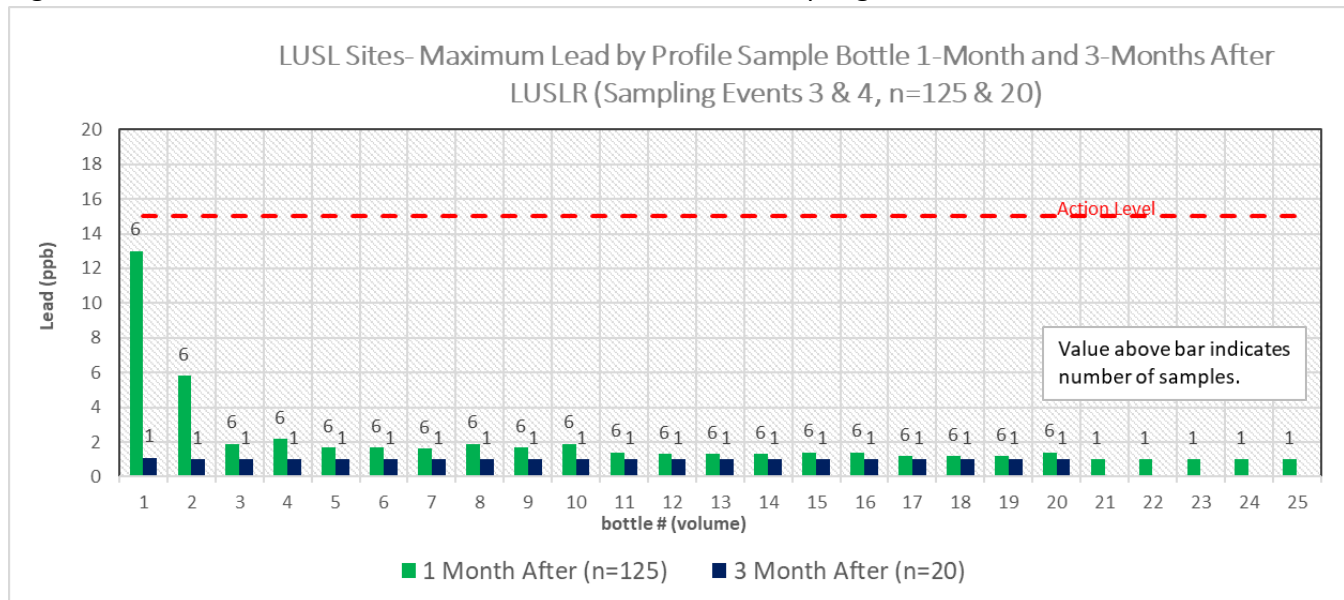
Figure 9 – Maximum Lead Results 1-Month and 3-Month Sampling after LUSLR

Notes: Values  $< DL$  reported as 1ppb

The Pilot Study plan called for closing out the final 2 sites with additional 3-month sampling due to 1-month results  $> 2$ ppb. Only one site was able to complete 3-month sampling and all results were  $\leq 1.1$ ppb (19 of 20 sample bottles were ND). Figure 9 shows maximum lead values from each profile bottle for sampling 1-month and 3 months after LUSLR.

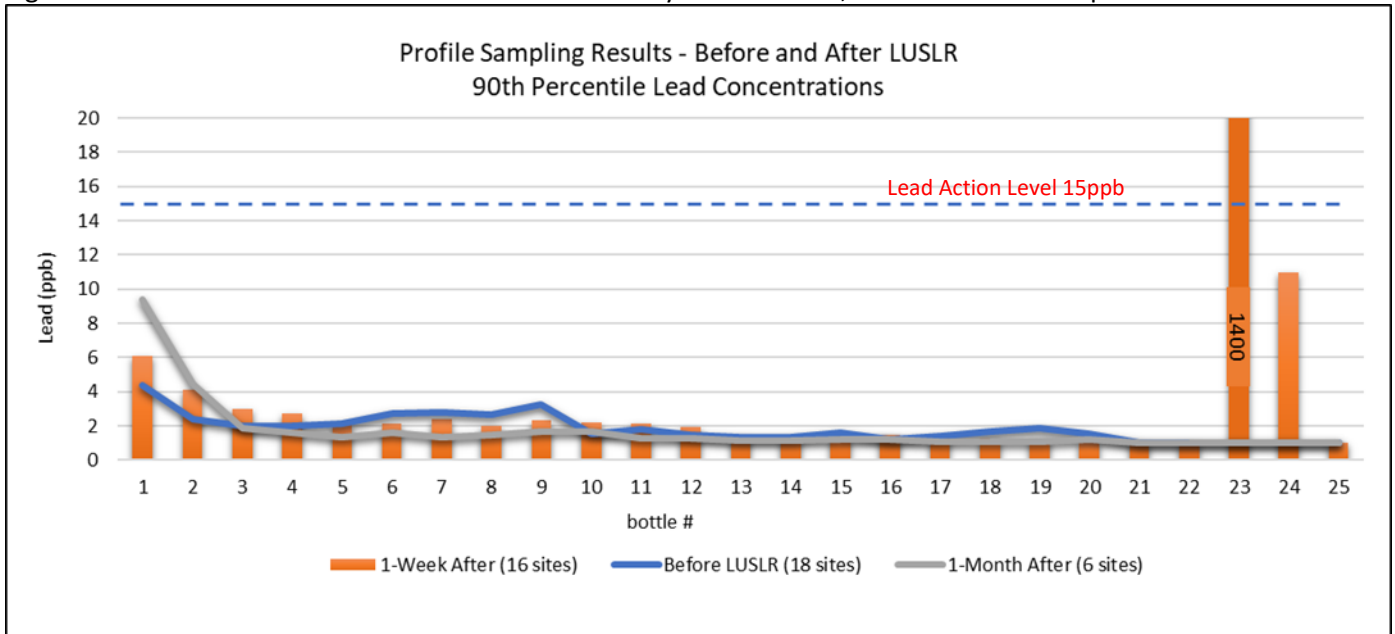
Figure 10a. 90th Percentile Site Lead Concentrations by Profile Bottle, Before and After Replacement

The number of sample bottles collected for profile samples varied from 14 – 25 due to estimated plumbing lengths. Values at <DL are shown as 1ppb.

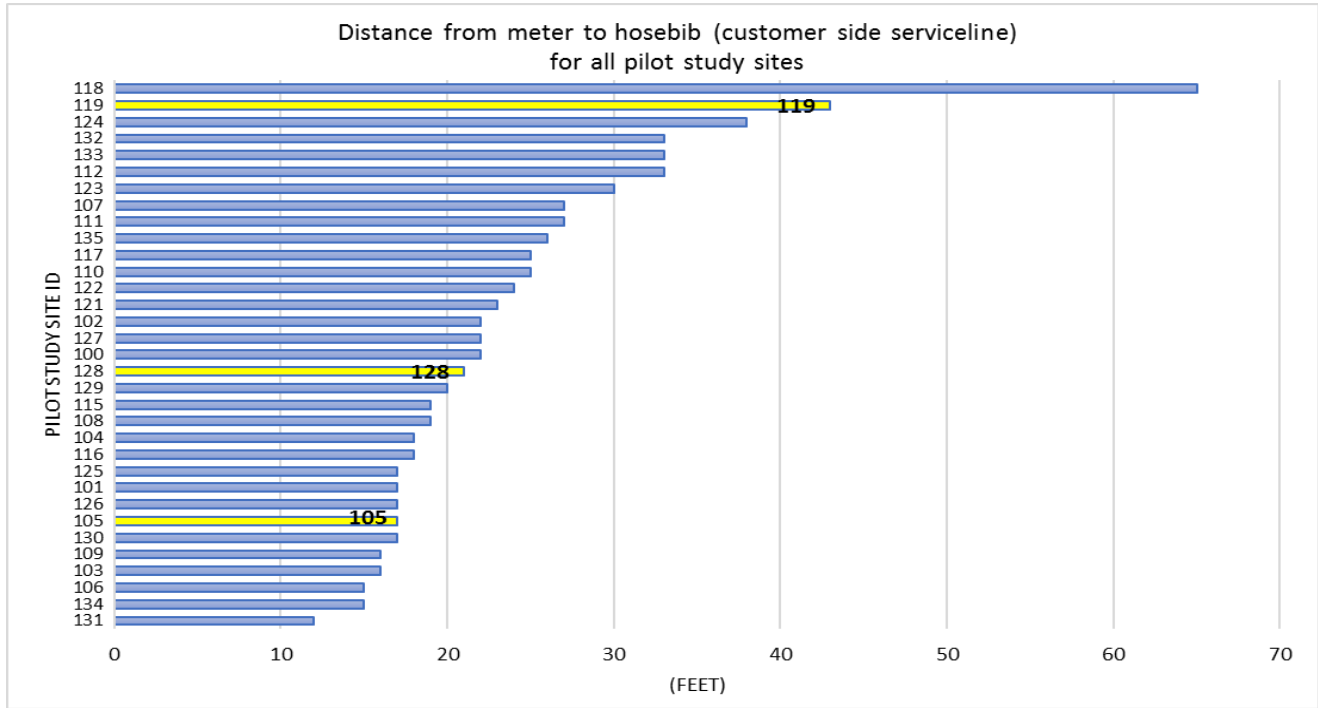
Figure C-2 – Distances meter to Hosebib for Pilot Study Sites, with highlighted sites 119, 128, 105

As charted in Figure C2, for all sites pilot study sites, the average length of pipe measured from meter to house is 24 feet. For this site, the longer than average galvanized pipe length from meter to house of 43 feet may create a higher surface area for settleable materials to deposit.
